Manhole Inspection Summary

Manhole # S33A__005MH

Insp Date: **1/19/08 12:42 PM**

Location Address: **610 CATHEDRAL ST**

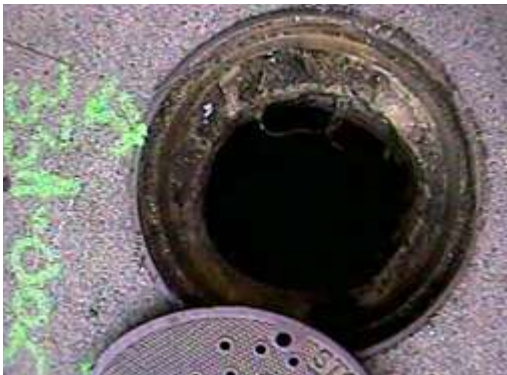
Top View

Offset: **4** (in.)

FRAME OFFSET

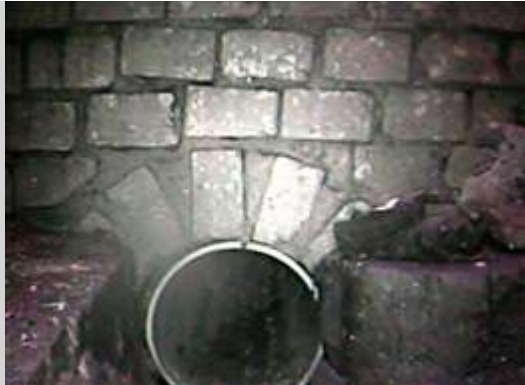
12 O'Clock Outflow

8 in. Circular Gravity Sewer
Pipe Out @ 12 O'Clock

DEBRIS ON BENCH

Pipe Height: (in.) Direct
Pipe Material: **PVC** ☐ Pipe Lined
Invert Depth: **8.92** (ft.) Flow Characteristics: **Fast**
Deposits: ☒ None ☐ Mud ☐ Sludge ☐ Debris ☐ Grease
Silt Depth: (in.) Deposits Extent:
Infiltration: **None** Pipe Seal Cond: **Sound**

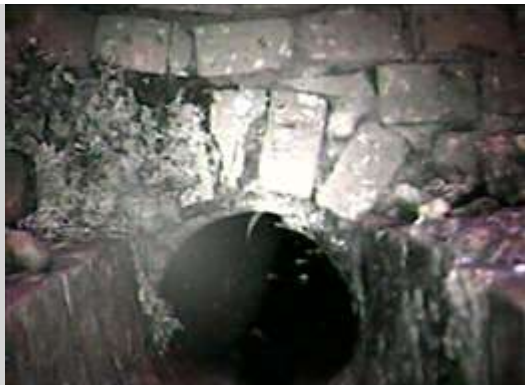
5 O'Clock Inflow

8 in. Circular Gravity Sewer
Pipe In @ 5 O'Clock

Pipe Height: (in.) Direct
Pipe Material: **Clay** ☐ Pipe Lined
Invert Depth: **8.95** (ft.) Flow Characteristics: **Slow**
Deposits: ☒ None ☐ Mud ☐ Sludge ☐ Debris ☐ Grease
Silt Depth: (in.) Deposits Extent:
Infiltration: **None** Pipe Seal Cond: **Sound**

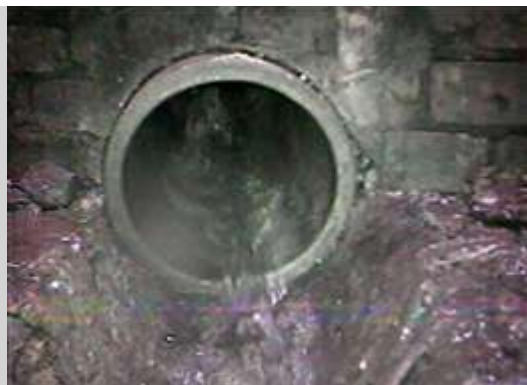
7 O'Clock Inflow

8 in. Circular Gravity Sewer
Pipe In @ 7 O'Clock

Pipe Material: **Clay** ☐ Pipe Lined

Invert Depth: **8.60** (ft.) Flow Characteristics: **Fast**

Infiltration: **None**

Pipe Seal Cond: **Sound**
